# Situation of wastewater management under disasters

# 1. Tsunami traces when the Great East Japan Earthquake (Former Kitakami River mouth, Ishinomaki City, Miyagi Prefecture)

## 4. What happened to the Johkasou?—From the damage situation—

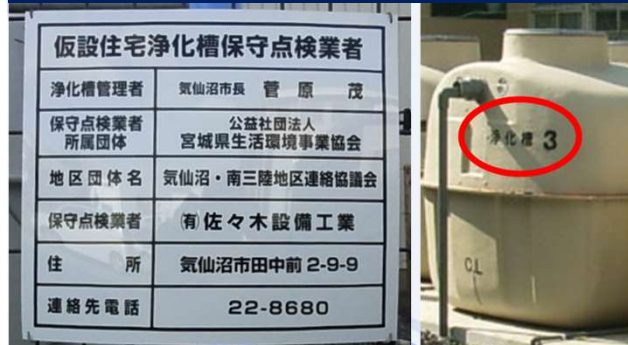
improvement approach for maintenance  
(sign boards and numbering)

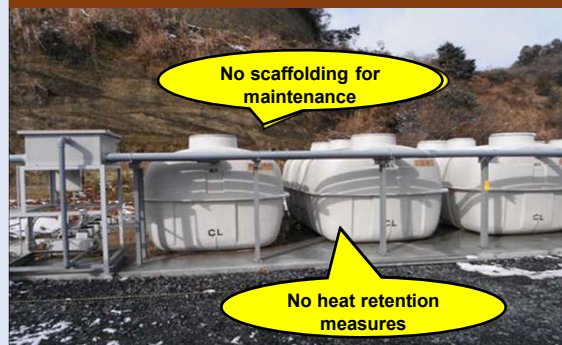
No scaffolding for maintenance  
No heat retention measures

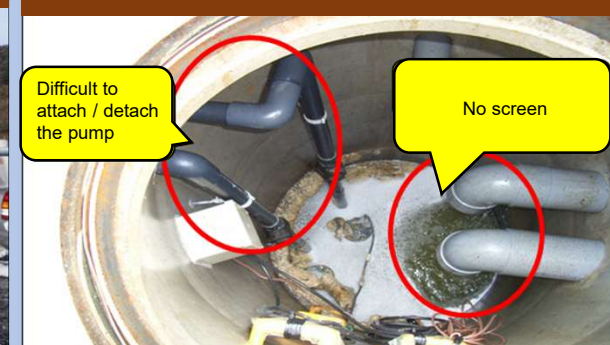
Inadequate screen equipment

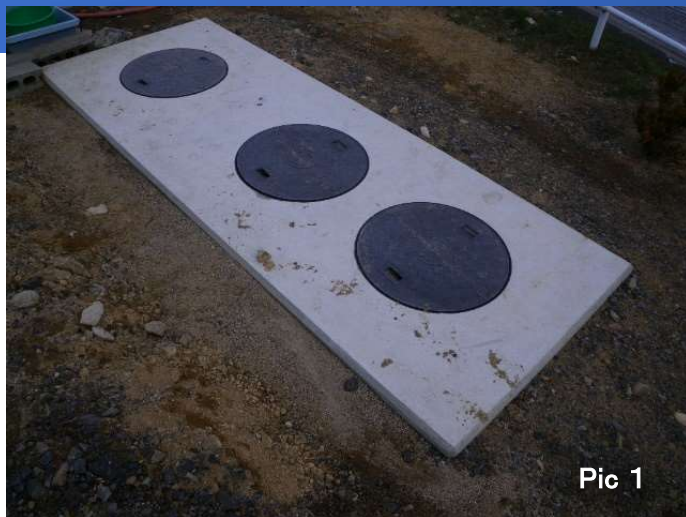
Pic 1

Iwate Prefecture  
(underground : 35 PE)

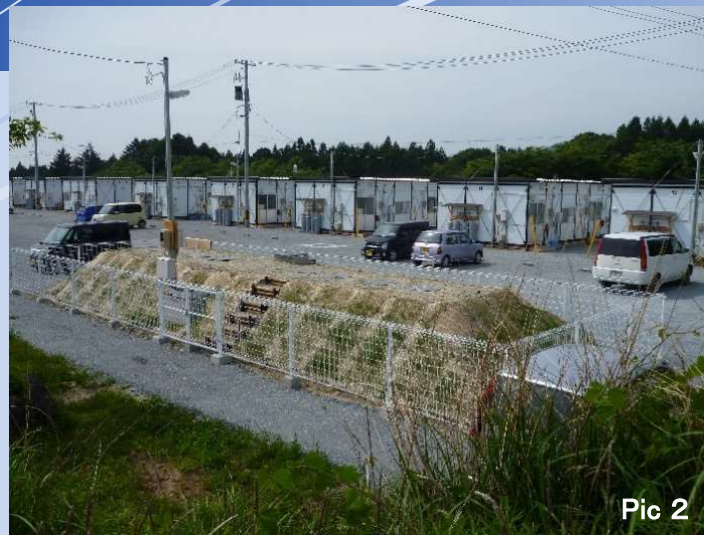
Pic 2

Fukushima Prefecture  
(Semi-underground installation + embankment:  
45 EP × 2 units)

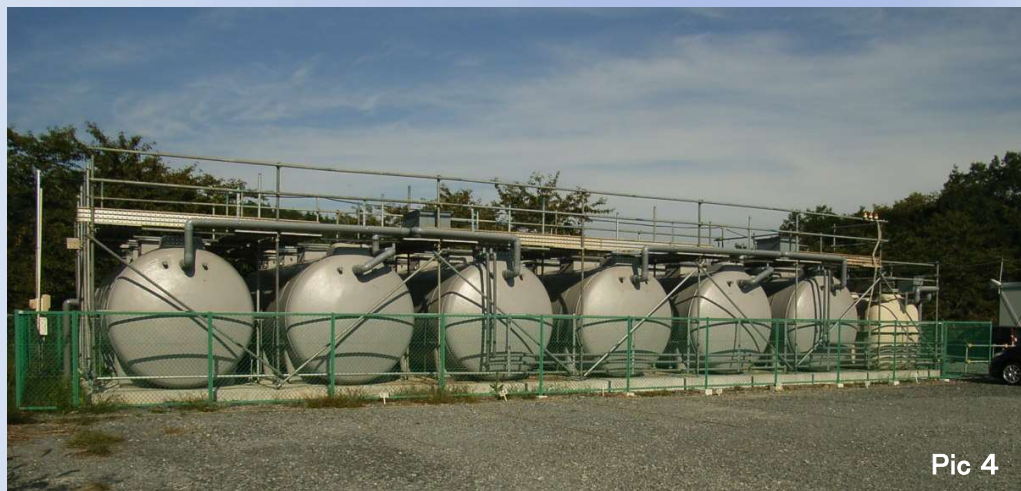
Pic 4

Iwate Prefecture  
(Ground installation, No heat retention measures:  
90 PE × 6 units + 30 PE)
