# Situation of wastewater management under disasters

# 1. Tsunami traces when the Great East Japan Earthquake (Former Kitakami River mouth, Ishinomaki City, Miyagi Prefecture)

## 4. What happened to the Johkasou?—From the damage situation—

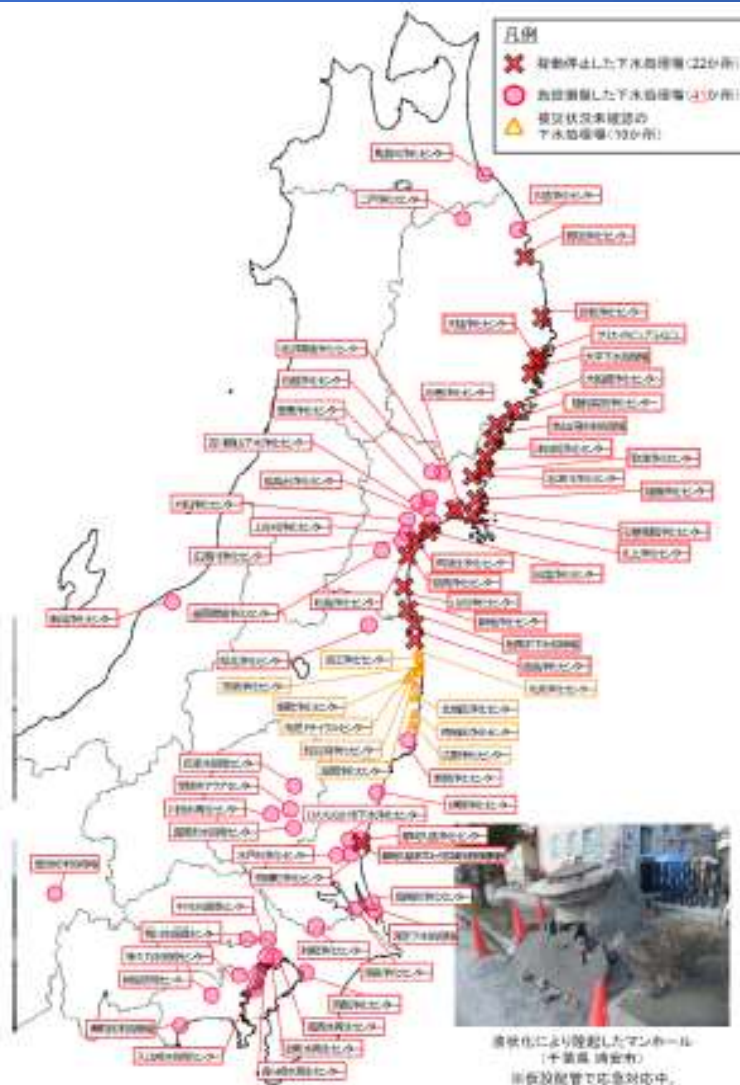
## 2. Situation of damaged sewer system

Treatment facility	Immediately after the disaster	2 <sup>nd</sup> May, 2011
Shut down	46	18
Damaged	63	44
Normal operation		48
unknown	11	10
Total	120	120

It took about 2 to 3 years to fully recover.

Pump facility	Immediately after the disaster	2 May 2011
Shut down	78	41
Damaged	30	31
Normal operation		36
unknown	1	1
Total	109	109

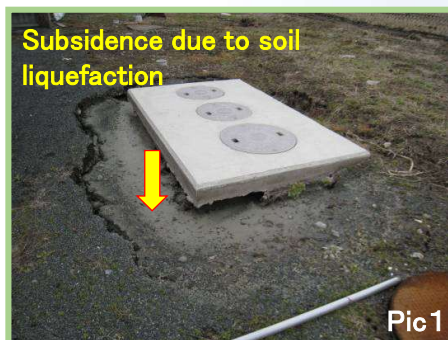
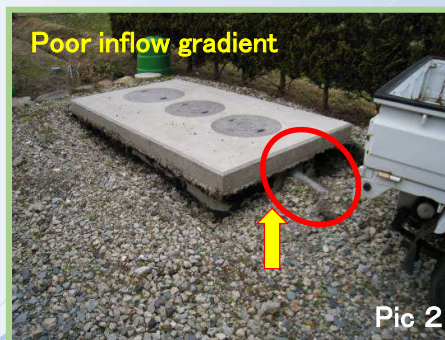
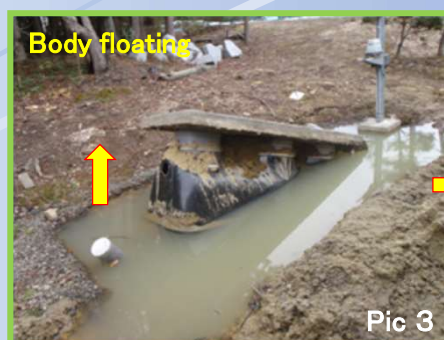
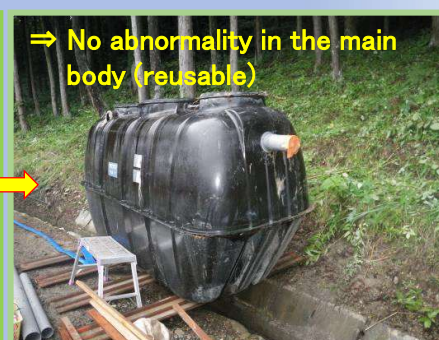
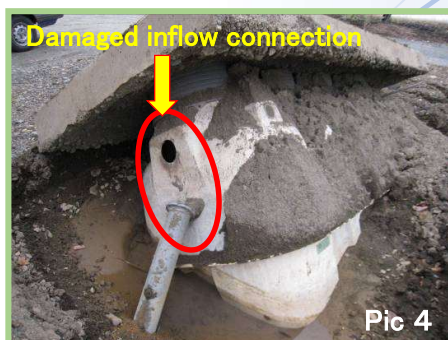
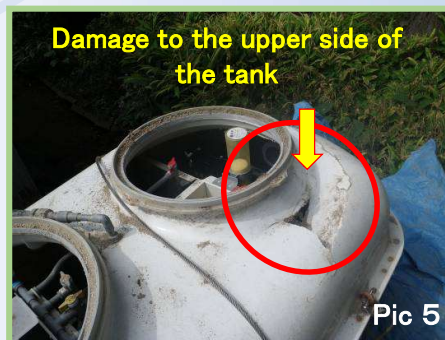
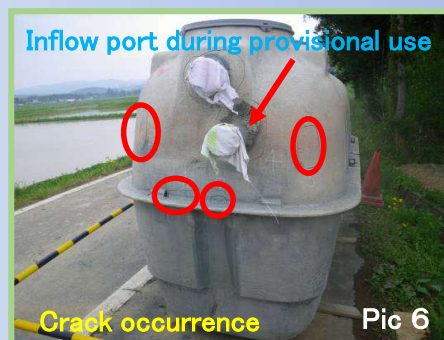
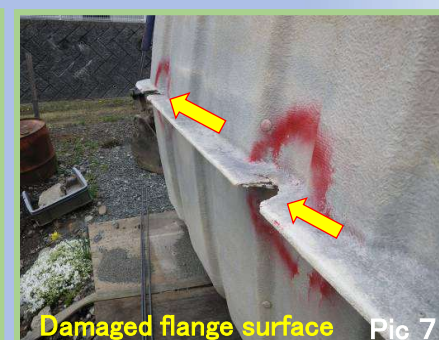
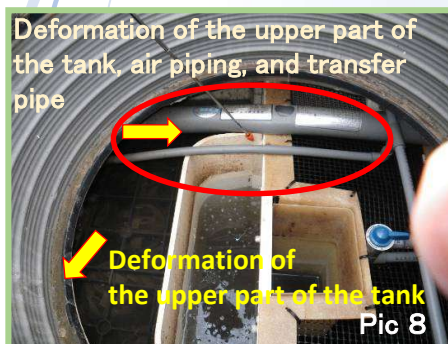
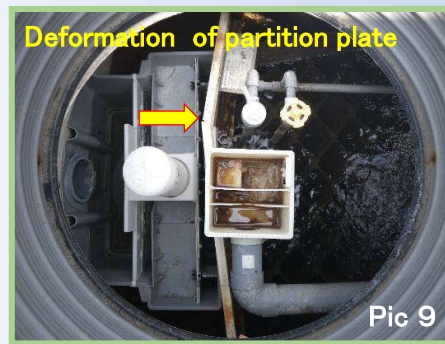
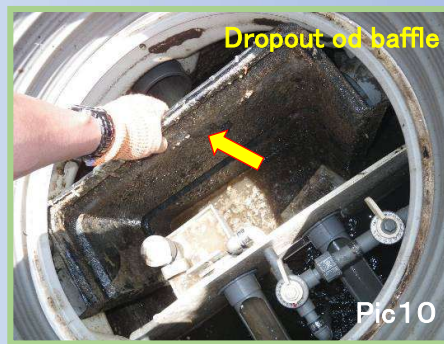
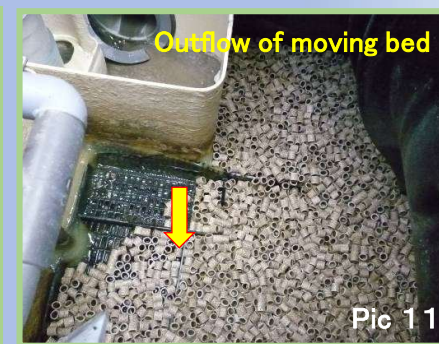
### 4.1 Cases of Johkasou damage caused by an earthquake

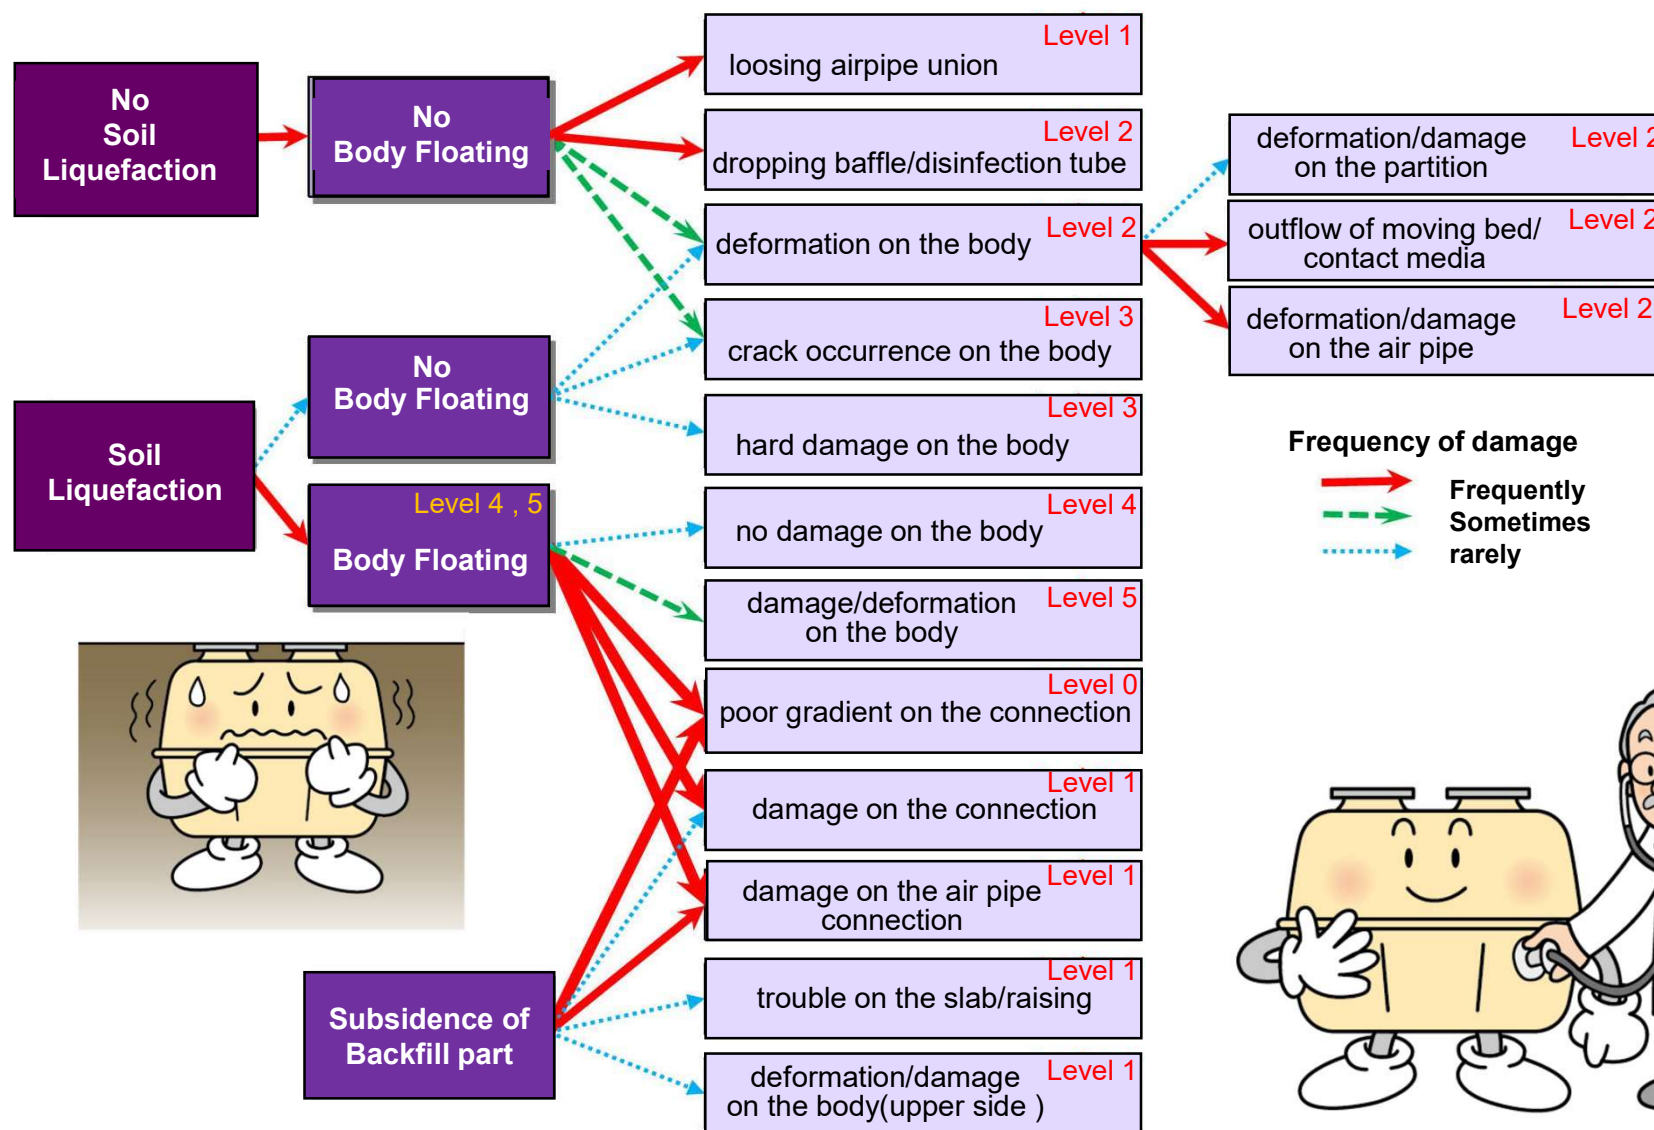
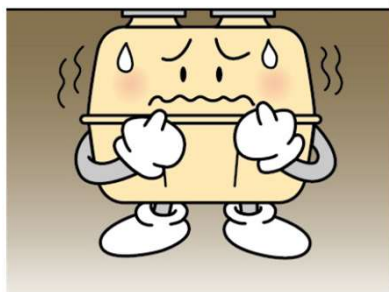
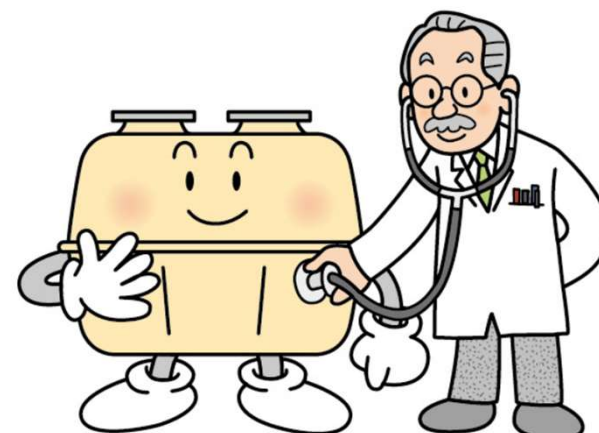
## 4.2 Classification of damage for Johkasou caused by an earthquake (Classified by the presence or absence of liquefaction)

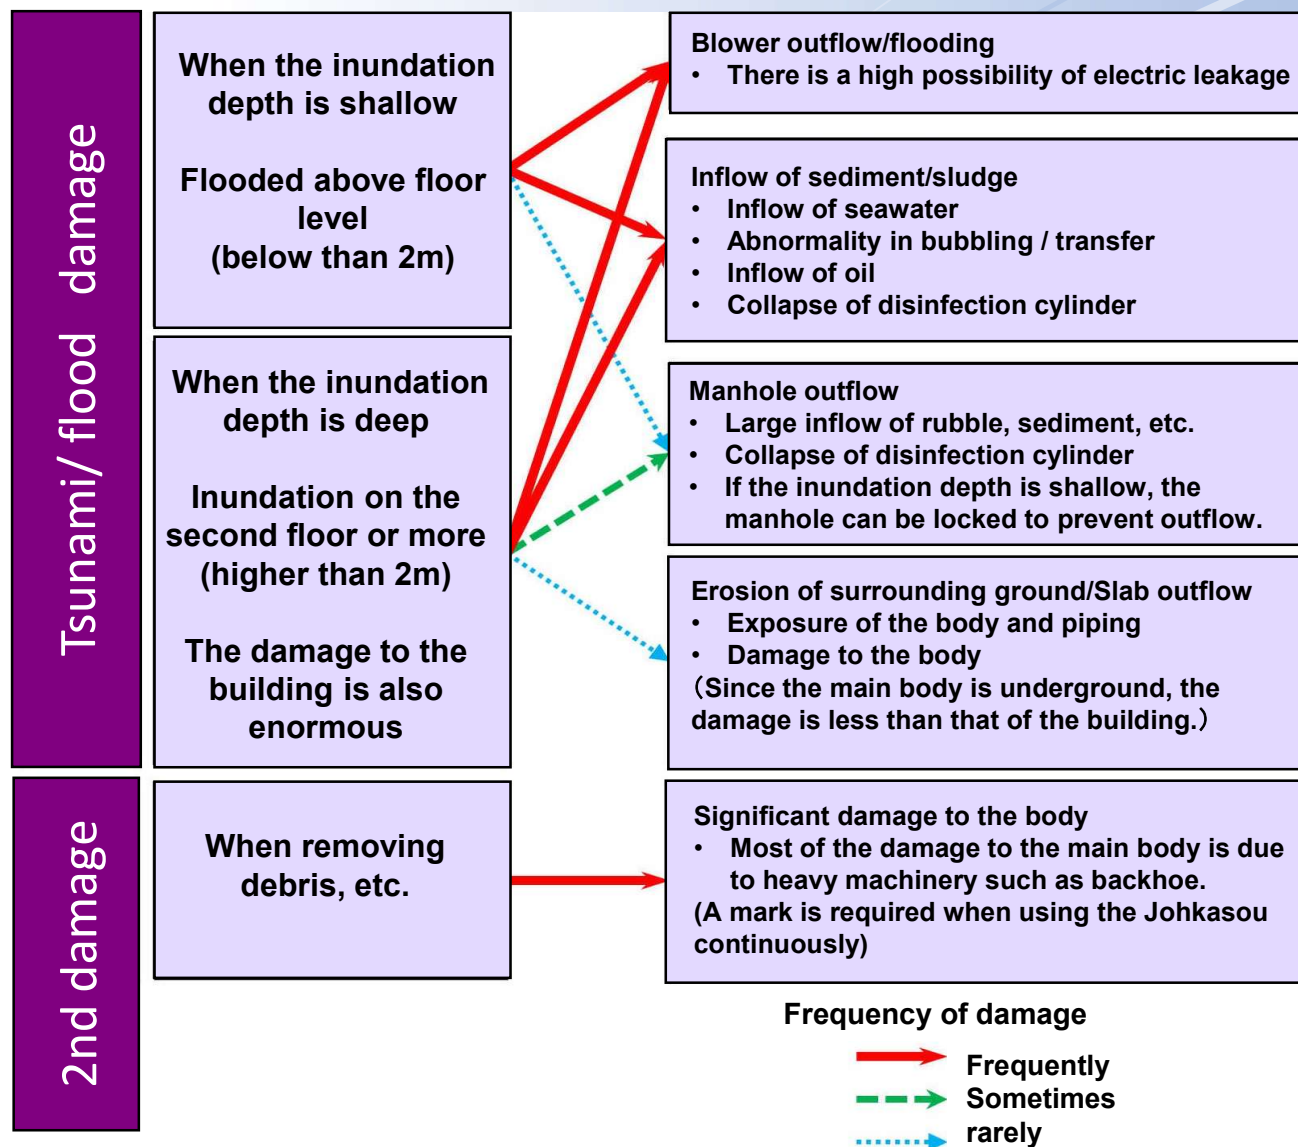
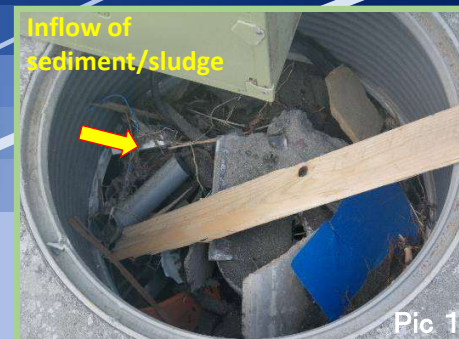
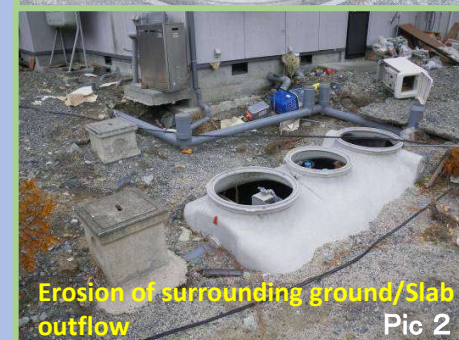
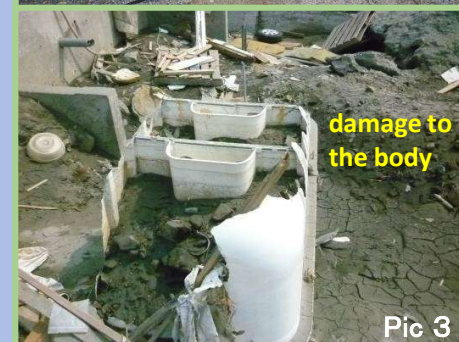
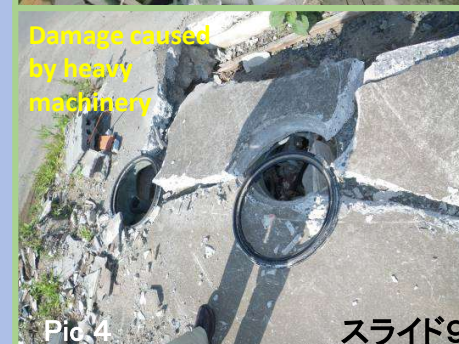
## 4.5 Classification of damage for Johkasou caused by tsunami (flood) and damaged case of Johkasou
